AIR BLAST PERFORMANCE TEST REPORT

ASAP WALLS

PRODUCT TYPE: Multilayer Security Wall

Report No.: E6722.01-119-19

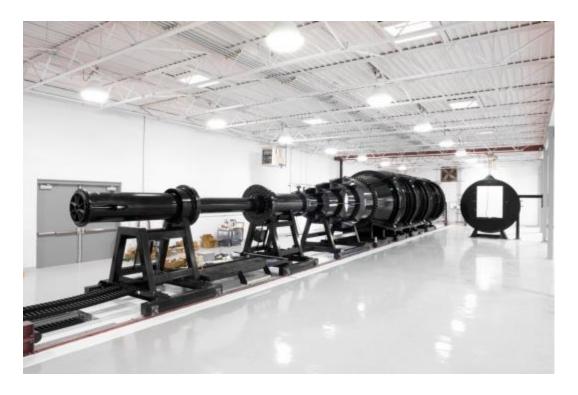
Figure #1
Shock Tube and Test Facility

- **1.4 Test Date**: 04/16/15
- **1.5 Test Facility**: Intertek-ATI's shock tube is housed in a 10,000 square foot state-of-the-art test facility located in York, Pennsylvania. Blast loadings are produced on the specimen to simulate the effects of a high explosive charge at a specified standoff distance. Shock waves are generated by the sudden rupturing of a thin aluminum membrane. The shock wave expands as it travels down the tube and impacts the target with a specific positive pressure and impulse. A photograph of the shock tube is provided in Figure #1 of Appendix A.

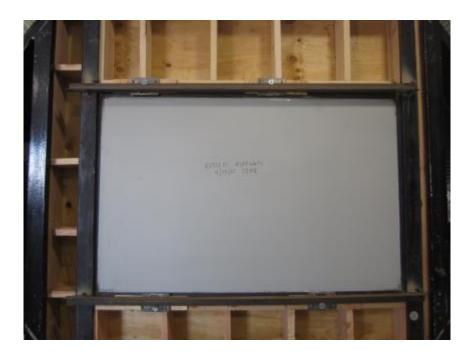
Photo No. 1
Pre-Test Condition of Wall Specimen, Interior

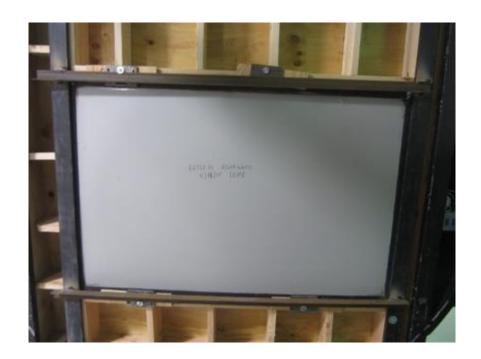
Photo No. 2
Post-Test Condition of Wall Specimen, Interior

The s-Wall had a maximum 15/16" permanent bow deformation at the center of the panel after the test.

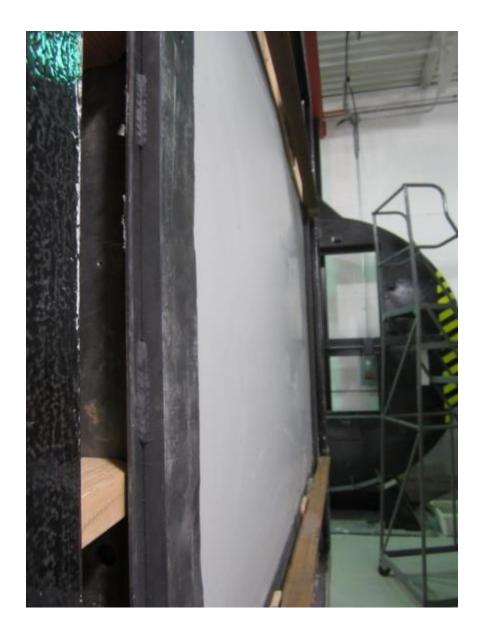
Photo No. 3
Post-Test Condition - Slight Permanent Deformation of *s-Wall* Panel
